Figure 2-2. Summary Events Chart and Accident Chronology

2.2 HAZARDS, CONTROLS, AND MANAGEMENT SYSTEMS

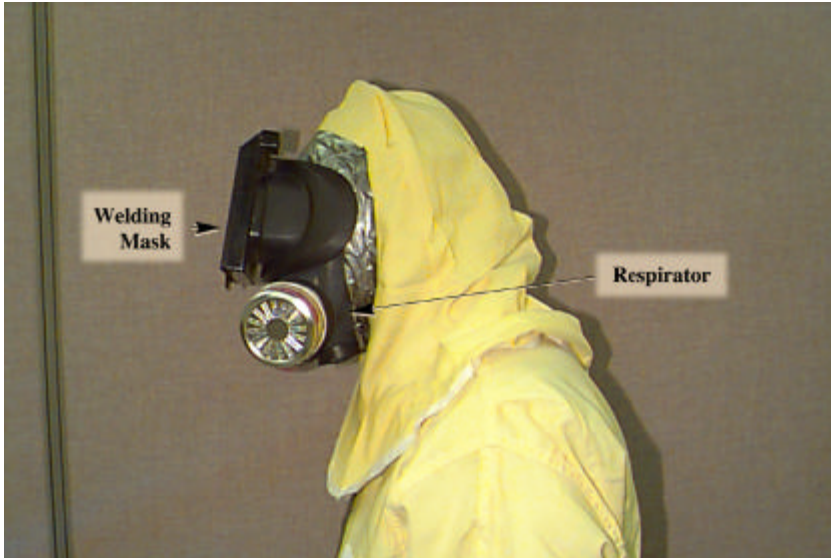
Exhibit 2-3. Welder's Outfit with Hood and Respirator (Closeup)

The Welder's training was up-to-date. The Welder had no physical, mental, or other impediments that impacted his performance. The Welder's peripheral vision and sense of smell were impaired by the requirement to wear a full-face respirator under a welder's mask while he was working (see Exhibit 2-3). The two sets of anti-contamination coveralls, in conjunction with the blue general-purpose coveralls, resulted in a bulky garment with many folds and creases that could have captured sparks or molten slag produced from the cutting/welding process (see Exhibit 2-1). Further, his
